NAVY AREA-WIDE RESTORATION ADVISORY BOARD
MEETING MINUTES
HYATT REGENCY GUAM BALLROOM
APRIL 3, 2003, 7P.M.

Proposed Plan
for the
Construction Battalion (CB) Landfill
South Finegayan, Guam

Proposed Plan

Closed Construction Battalion Landfill, Naval Computer and Telecommunications Area Whistler Station, South Finegayan, Guam

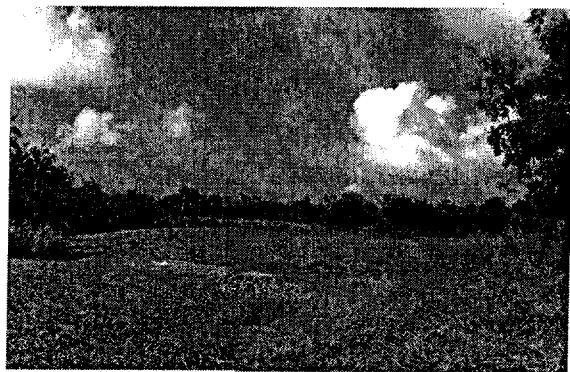
South Finegayan Construction Battalion Landfill (PWC)

- Cleanup (capping) completed in June 1998
- Continue Semi-annual Groundwater Monitoring
- Continue Cap Maintenance

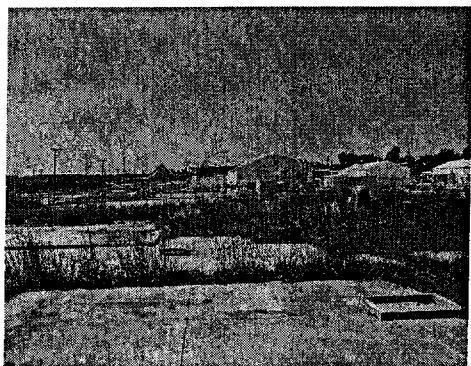
Building 3009 (PWC)

- Treatment of PCB Contaminated Soil Completed in Mar 1997
- Final Site Inspection Work Plan/Sampling and Analysis Plan will be completed at the end of 2003

Site Name	Description	Site Information	IR Document	Future Activities
Building 3009, PWC Guam	<p>Building 3009 was used as an electrical transformer repair shop from 1950 to 1977. Electrical transformers were overhauled there, which involved the cleaning and repairing of parts and the recycling of transformer oils. Four storage tanks were located besides the building with two filtering systems; one for mineral oil and the other for PCB oil. In 1977, the PCB filter system and piping were removed due to leakage from the PCB storage tank.</p> <p>Soil samples taken around the building and along a portion of the nearby drainage ditch identified significant polychlorinated biphenyls (PCB) contamination. A Removal Action was performed using the Base Catalyzed Decomposition Process (BCDP) due to the high levels of PCB detected at the site. Treatment of PCB contaminated soil was completed in 1997. A Site Inspection (SI) will be conducted to assess the nature and extent of contamination remaining on this site.</p> <p>Additional soil samples were taken in Nov 1998 to determine the extent of 2 hot spots.</p> <p>Draft SI Work Plan/Sampling and Analysis Plan completed in October 2000 which is available for review and comment.</p>	<p>Final Remediation Verification Report (Dec 1998).</p> <p>Draft SI Work Plan/Sampling and Analysis Plan (Oct 2000)</p>	<p>Final SI Work Plan/Sampling and Analysis Plan (Summer 2003)</p> <p>A Site Inspection (SI) is scheduled for FY 2004</p>

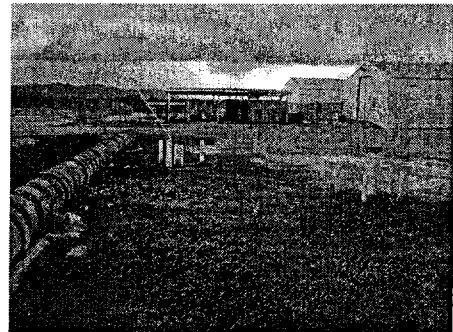
Site after cleanup (Dec 2002)

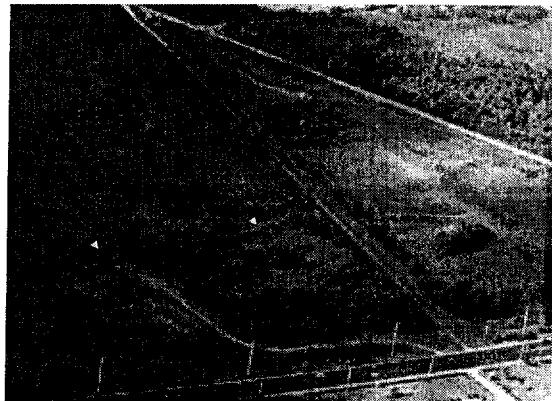
Lower Sasa Fuel Burning Pond (COMNAVMARIANAS)

- Evaporation pond removed in 1999
- Approach Document for Ecological Risk Assessment (Feb 2002)
- Cleanup Strategies to be finalized in 2004

Site Name	Description	Site Information	IR Document	Future Activities
Lower Sasa Fuel Burning Pond, COMNAVFMAR (formerly FISC Guam)	<p>The Lower Sasa Fuel Burning Pond was used from early 1959 to 1970 as a collection pond and burn pit for waste petroleum, oil and lubricants generated from various Navy activities. The pond received waste from an oil/water separator, which developed mechanical problems allowing oily wastewater to drain into the holding pond. Water at the bottom of the pond was drained into the adjacent wetlands via drainage channel and the remaining petroleum residue was then burned.</p>	<p>Surface water and groundwater, surface soil and subsurface soil, sediment and biological tissue samples were collected and analyzed to determine the extent of contamination. Total extractable petroleum hydrocarbons (such as gasoline, diesel, kerosene, and lubricant oil) as well as oil, grease, metals, polynuclear aromatic hydrocarbons (PAH) and pesticides were detected on this site. The contaminants were primarily detected in the sediment samples taken from the drainage channel and mouth of the channel. The results of the human health risk assessment concluded that the site does not pose a significant risk to humans. However, the ecological risk assessment identified significant risk to ecological receptors due to the PAHs and mercury found within and at the mouth of the drainage channel.</p> <p>Based on the comments from the regulators, the Engineering Evaluations/Cost Analysis (EE/CA) recommended alternative 3 instead of alternative 4.</p>	<p>Final Engineering Evaluation/Cost Analysis (EE/CA) Report (Dec 1997)</p> <p>Final Action Memorandum (Aug 1998)</p> <p>Draft Removal Action Design (Aug 1998)</p> <p>Final Sampling and Analysis Plan /Health and Safety Plan (Jan 2000)</p> <p>Final Revised Screening Ecological Risk Assessment (Dec 2001)</p> <p>Approach for the Ecological Risk Assessment (Feb 2002)</p> <p>An Action Memorandum will be signed to document the selected alternative.</p> <p>Draft Baseline Ecological Risk Assessment (Fall 2003)</p> <p>Finalize the Removal Action Design (Winter 2003)</p> <p>Finalize Cleanup Strategies in 2004</p> <p>Sighting of common moorhen was reported in the Lower Sasa wetland area in 1999. This change in site condition requires additional data to properly assess the ecological risk to the common moorhen. Additional sampling was conducted in January 2000.</p> <p>The results of the draft revised Screening Ecological Risk Assessment identified that concentrations of the chemicals of potential concern are above the screening standard indicating that a more in-depth ecological risk assessment (baseline ecological risk assessment) is necessary.</p>

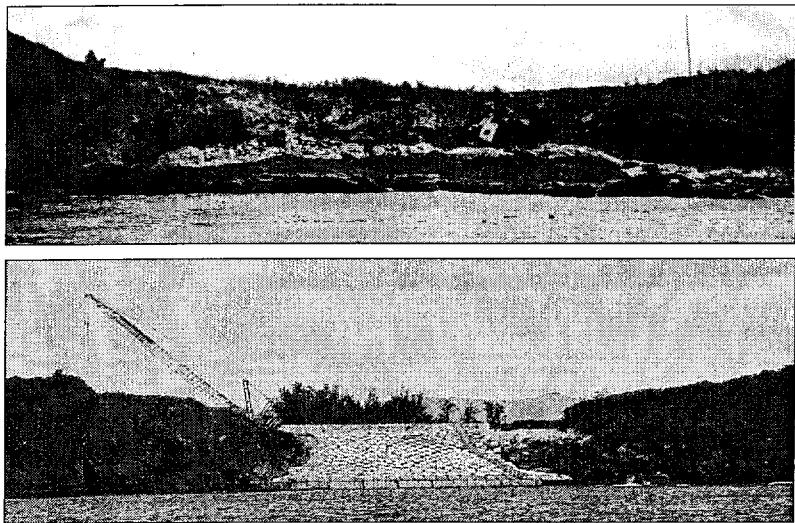
Orote Beach Before and After Construction of the Seawall

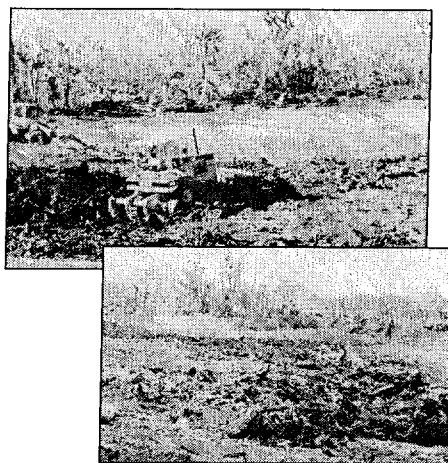
Site History

- Landfill was Established in 1944
- Operational through 1957
- Used for Waste Disposal from the Construction Battalion Maintenance Shop
- Disposal of Scrap Metal, Construction Debris, Waste Petroleum-Based Oil, Lubricant and Solvent Wastes

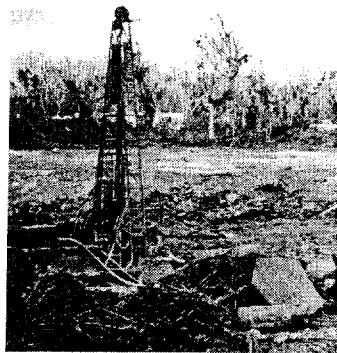
Site Investigation Findings

- Rubbish extended over an area of 2.6 Acres to a maximum depth of 35 feet
- Surface Soil Found to Contain Wastes
- Subsurface (Soil and Groundwater) found to be OK
- Methane (a Common Landfill Gas) Not Detected

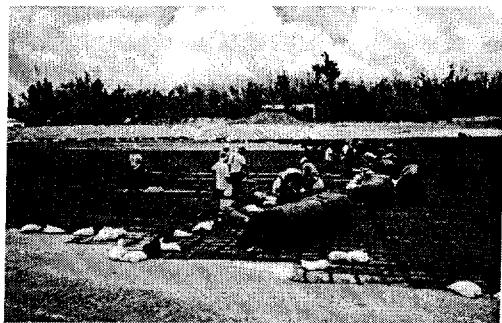
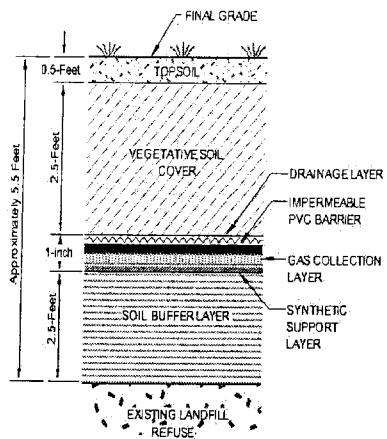
Site Cleanup and Construction

- Soil Buffer Layer
- Landfill Gas Collection Layer

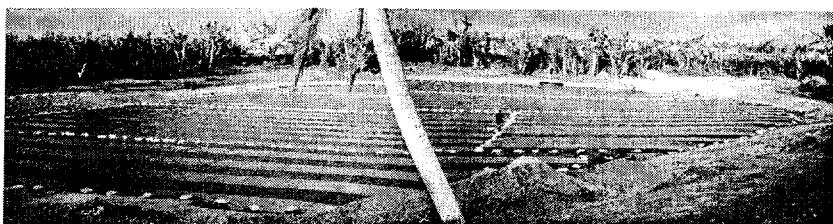
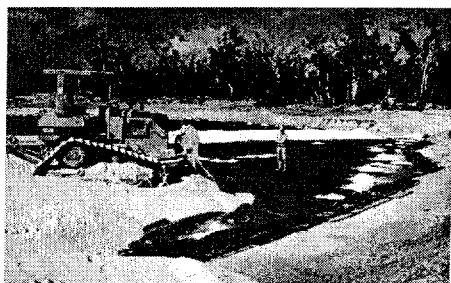
- PVC Cap Installation
- Vegetative Soil Cover
- Site Drainage

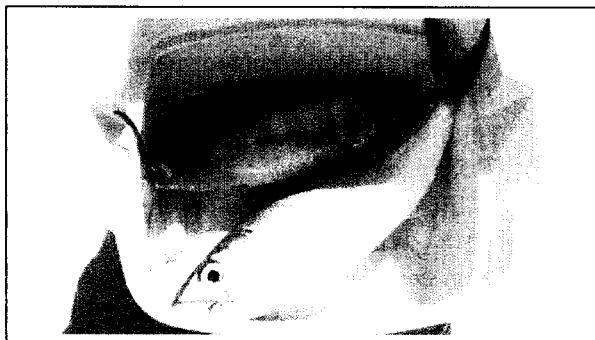
Fig. 2. Fish collected for analysis – Lehi or silvermouth

A total of 16 different mid and deep water fish species were caught for analysis (see Fig. 2 and 4). They include:

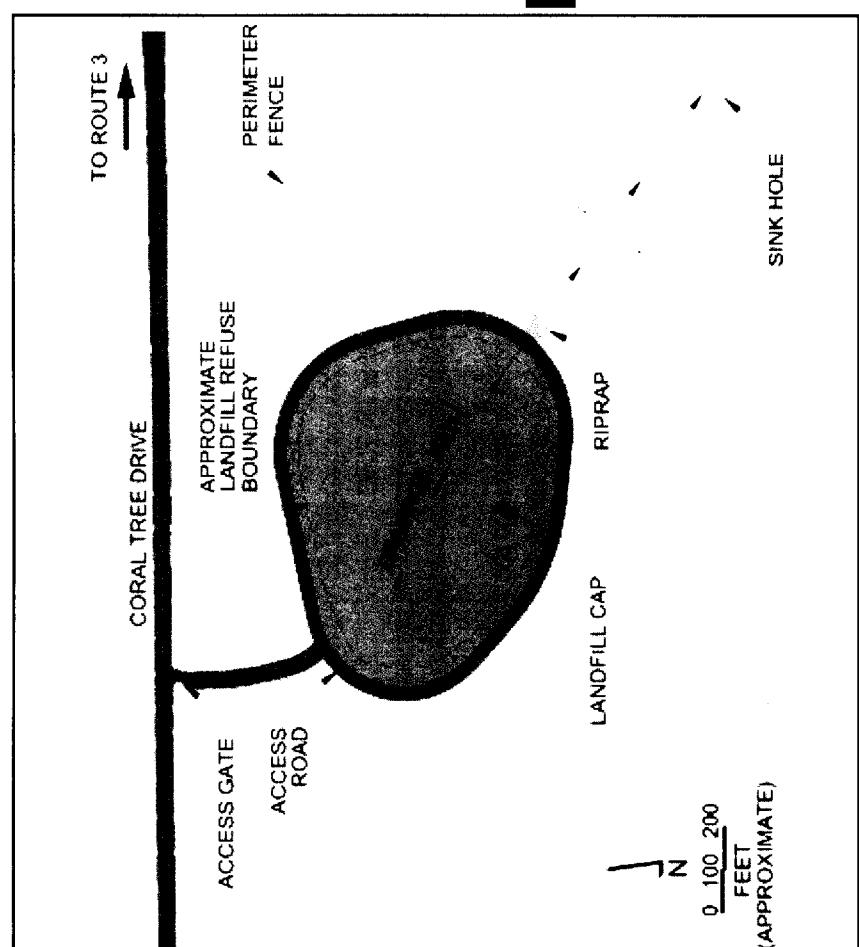
Figure 3: Site Map

pounds (VOCs), metals, polychlorinated biphenyls (PCBs), polynuclear aromatic hydrocarbons (PAHs) and pesticides. No VOCs, PCBs, pesticides or PAHs were detected in groundwater samples collected from the wells around the landfill, however other petroleum hydrocarbons (lubricant oil) and metals were detected at low levels. Landfill gases detected at the site were limited to a few VOCs. No methane (a common landfill gas) was ever detected.

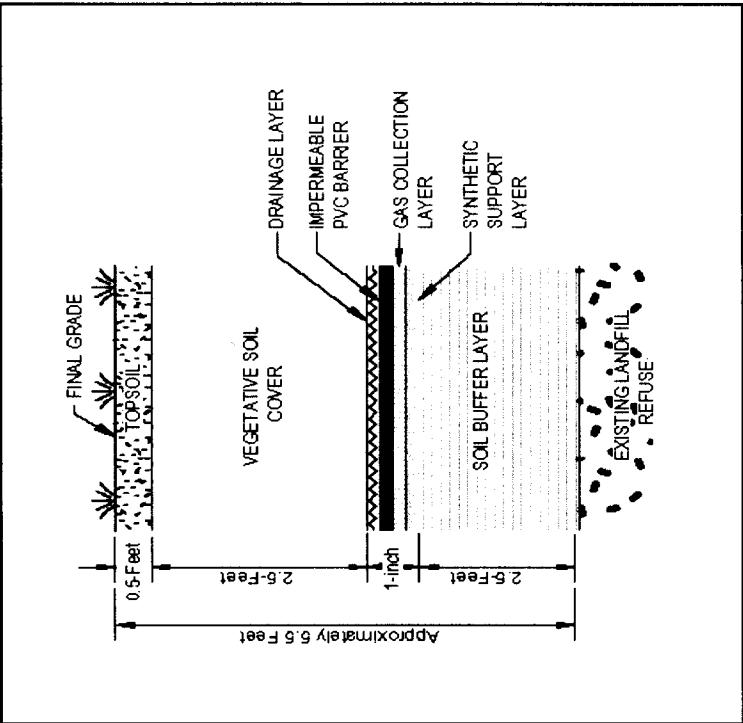
Figure 5: Landfill Cap System

Alternative 2 consisted of installing an impermeable cap over the landfill refuse (shown on Figures 4 and 5), providing storm water and landfill gas control, and installing a perimeter fence. The landfill cap consists of a waterproof polyvinyl chloride (PVC) barrier and a vegetative soil cover. Surface grading and drainage ditches were used to channel storm

water away from the landfill to a discharge location. Passive gas vents would prevent landfill gas from accumulating beneath the landfill cap system. The perimeter fence would restrict public access to the site.

The U.S. Navy, with concurrence from GEPA, performed the recommended cleanup at the CB Landfill in 1998. The cleanup included constructing a waterproof barrier cap over the top of the entire landfill refuse area (Figures 4 through 7), installing storm water and landfill gas control systems, and implementing a post-closure monitoring and maintenance program. A perimeter fence restricts public access to the site.
